Comprehensive Wastewater Treatment Plant Assessment and Evaluation

COMPREHENSIVE WASTEWATER TREATMENT PLANT ASSESSMENT AND EVALUATION REPORT

TOWN OF ROCKLAND, MASSACHUSETTS

WRIGHT-PIERCE

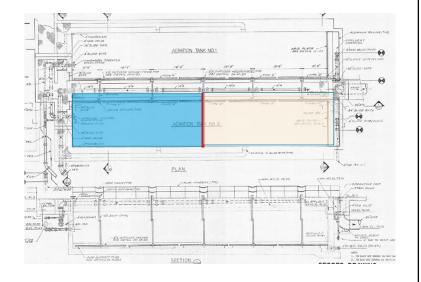
Sludge Storage Option 1

- 110,000 gal each
 - o 14 ft. wide x 13 ft. deep x 81.5 ft.
- WAS Design Max month:
 - 2,730 lbs./day at 0.9% = 30,000 gpd
- Primary Sludge Design Max Month:
 - 5,000 lbs./day at 2.5% = 23,000 gpd
- 3 to 4 days of storage capacity recommended
 - Pumps located in basement of Admin. Building

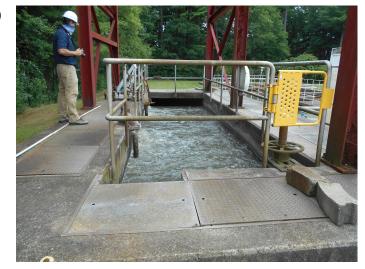
Influent Grit Removal

- Only 1 Existing unit (redundancy)
- Designed appropriately (tank geometry)
- Typically, decent at capturing large heavy grit, but less so lighter/fine grit
- Grit removal options
 - Replace clamshell grit bucket
 - Chain and flight
 - Screw conveyor
